Manhole Inspection Summary

Manhole # S23C1_002MH

Insp Date: **7/3/08 11:25 AM**

Location Address: **2410 Huron St**

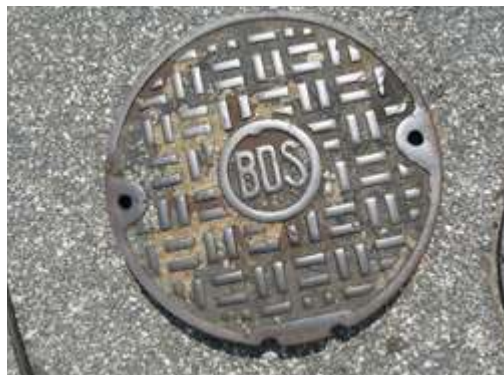
MH Cover

Frame Offset: **2.** (in.) Condition: ☐ Sound ☐ Cracked ☒ **Leaks**
25

Defect 3

frame lid infiltration, frame offset
